# **JOURNAL OF NEPAL GEOLOGICAL SOCIETY**

**ABSTRACT VOLUME**

**11<sup>TH</sup> IAEG ASIAN REGIONAL CONFERENCE (ARC-11)**

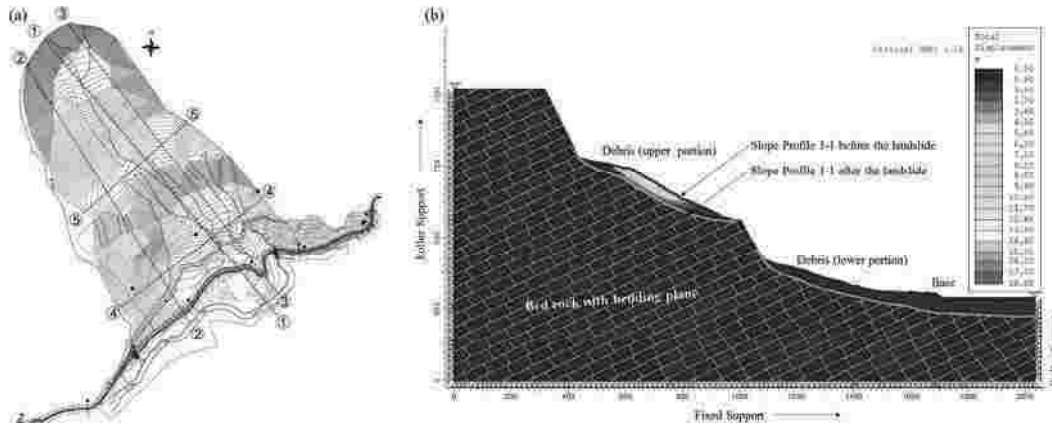
**Fig. 1, Typical numerical model of Jure landslide slope: (a) Contour map of the study area and (b) Computational results of total displacement (m) at Profile 1-1 (Mid Profile) of Jure landslide area along with modeling details in Rocscience Phase2 framework**

factor values were computed (Fig. 1). Mohr-Coulomb failure criterion along with strength reduction method was employed to analyze the slope (Matsui and Sam, 1992). Residual cohesion intercept values of soil layers and corresponding values of internal friction were obtained from lab tests. Back analysis was done to correct the data by taking constant cohesion value obtained from the lab tests (Table 1). The validation of the work was done with LEM-based program 'Slide' and also from the literature. As a result, satisfactory results and correlations were obtained. Then, a mitigation model was prepared based on factored safety factors (Table 2) based on Popescu (2001).

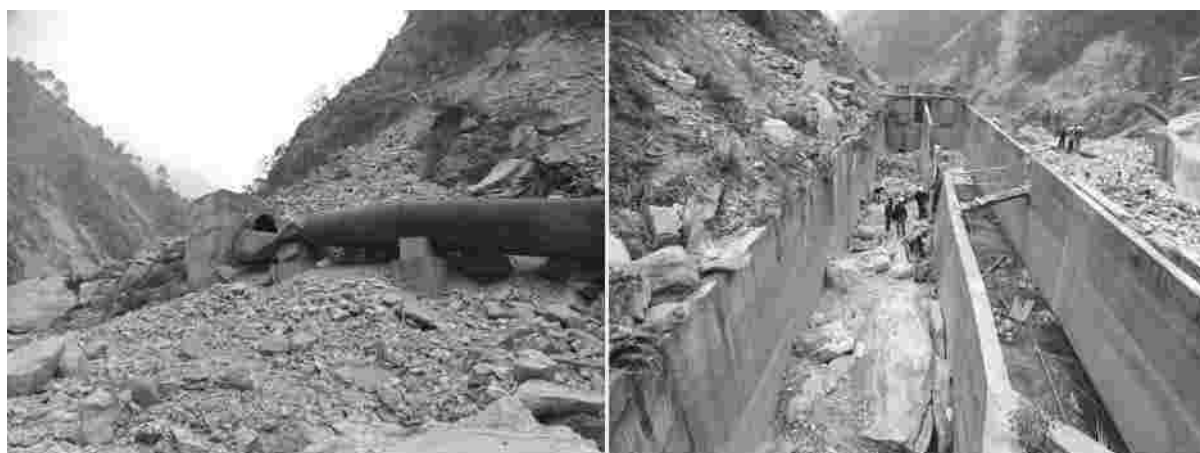
**Fig. 1, Penstock pipe and settling basin of 5 MW Mailung Project damaged by landslide and rock falls**

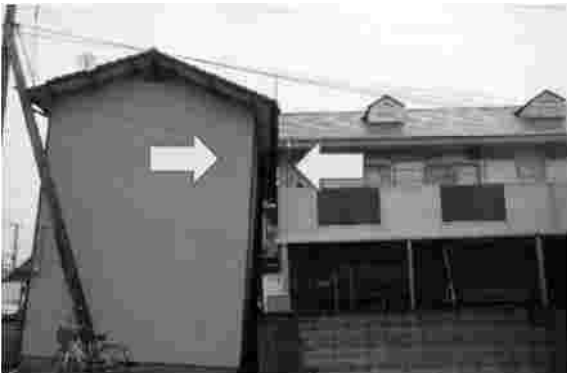
Fig. 1, Inclination of houses at Chikami in Kumamoto City
