In-situ Block Shear Test at Tanahu Hydropower Project, Tanahun District Western Development Region, Nepal

Madan Raj Pokharel

Nepal Electricity Authority, Tanahu Hydropower Project Trade Tower, Thapathali Kathmandu, Nepal

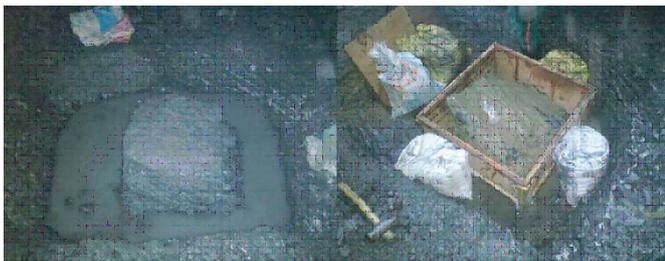
Proper cleaning of the drift floor from debris and excavation muck was done at the selected locations. The rock-to-rock test blocks were carved to the required dimensions (700 x 700 x 350 mm) from the parent rock mass using manual chisel and hammer to avoid disturbance or loosening of the natural rock (Fig. 2).

Fig. 2: Block Preparation

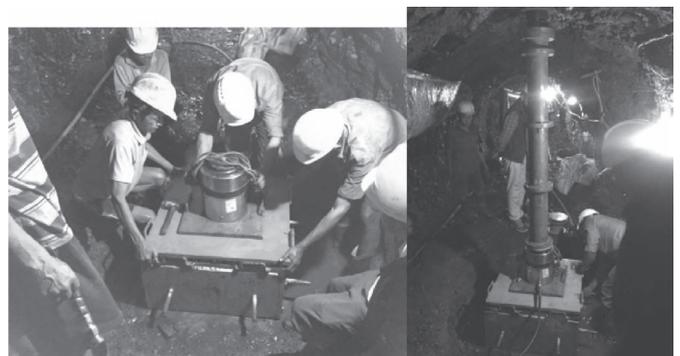
Then a remote controlled hydraulic jack of 2000 kN capacity was placed centrally over top plate. A reducer plate was also placed on the top of this plate similar to the size of the jack (Fig. 3). Spacer columns of appropriate length were placed over ram of the jack to reach normal reaction pad. The normal load was transferred from the normal reaction pad at crown through a spherical ball seat arrangement to maintain verticality of the normal load during the test. The contact between the normal pad and the column was made by displacing the jack. The hydraulic jack of suitable capacity for applying shear force was placed parallel to the base of the block due to practical hindrances, in spite of a 15-degree inclination. The jack applying shear force was positioned such that the line of action of the force passed as close as possible to the center of the shear area.

Reducer plates are also used on the shear reaction pad to disperse the load evenly into the wall. The normal load and the tangential force were applied such that their line of action intersected just above the centroid of the shear area at the base of the block. To record the displacements of the block, dial gauges having least count of 0.01 mm and a travel of 50 mm were used. Four dial gauges were placed to record normal (vertical) displacement, two for recording shear (horizontal) displacement. The dial gauges were fixed from a datum bar supported on stands located sufficiently away from the test blocks and the reaction pads.

Fig. 3: Setup the Block Shear Test Machine (ATES, 2017)

After adequate curing of the test block, the site was prepared for starting the shear tests. After dewatering, the block was cleaned and the base sides of the block were made free from any broken rock pieces so that the block was free to move in shear direction. A shear mould of 25 mm thick MS plates was encapsulated on the shear block to maintain the integrity of the block throughout the test. A 10-mm layer of fine sand was applied on top of the shear block to fill any void and undulations and ensure a perfect contact of loading plate with the block. A 25 mm thick mild steel plate of 700 mm x 700 mm size was placed on the block centrally for uniform distribution of normal load. Another plate of similar size was placed over it with an adequate roller arrangement sandwiched in between to allow free and smooth sliding movement in shear direction.
